# CORNER RECORD

Document Number 2N26-7-9

Brief Legal Description LOT 9, BLOCK 5 MODOCITY SUBDV. NO 2, SEC 7, T2N, R26E, N03E1/4

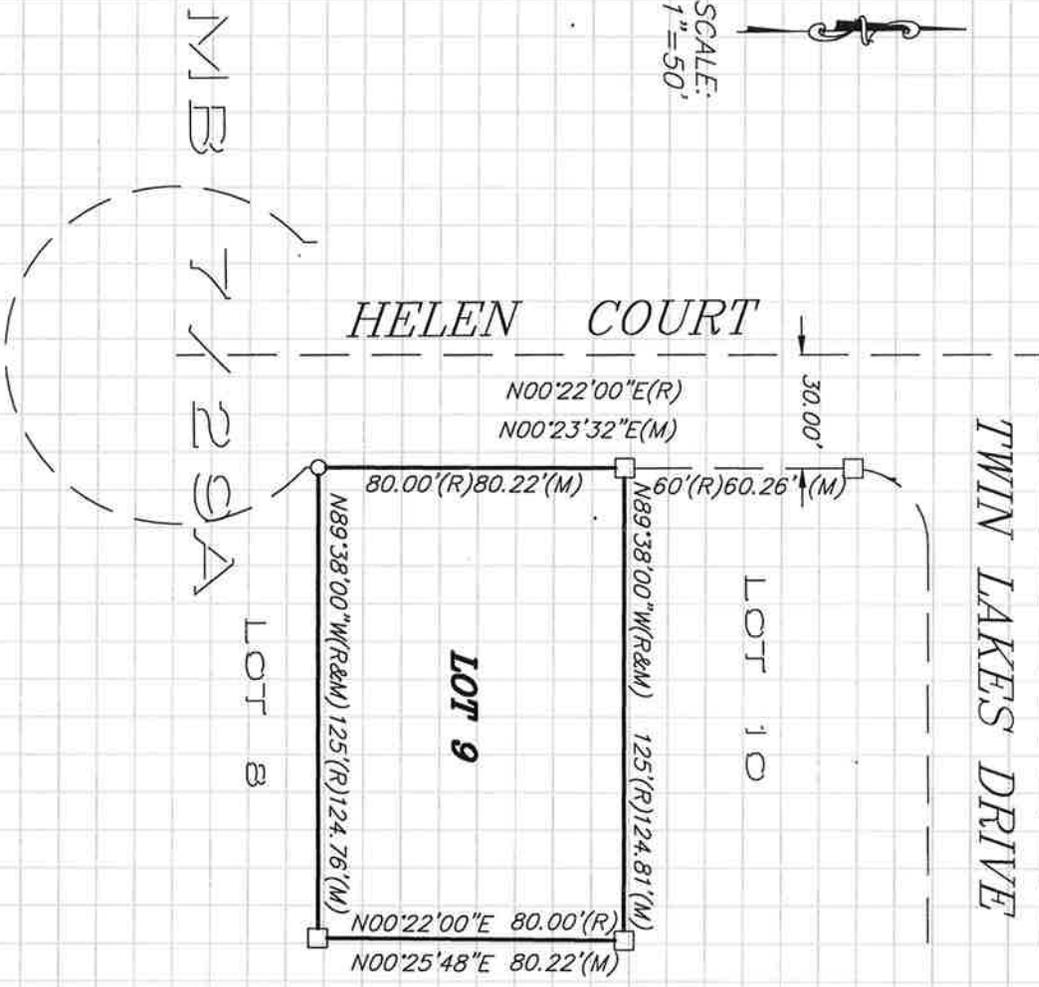
FIND REMAINS OF REDWOOD HUBS ORIG. PER MR 7/29 AT NW, NE & SE OF LOT 9, BLKS 5. ALSO FIND REDWOOD HUBS @ BCR OF LOT 10 ON HELEN COURT. THESE HUBS HAD 3/8" REBAR ADJACENT TO THEM. DIRECT REPLACED ALL REDWOOD HUBS WITH 3/8" REBAR & CAPS "LS 4587". HELD HUBS ON HELEN COURT FOR LINE ON FRONT OF LOT 9 & REC. BEARING FROM END SE. TO ESTABLISH THE SW OF LOT 9

A description of the physical condition of the monument as found and as set or reset: SET 3/8" REBAR CAP "LS 4587" @ NW, NE, SE & SW CORNERS OF LOT 9. ALSO SET SAME @ BCR OF LOT 10 ON HELEN COURT

THE NORTH LINE OF LOT 9 PER MB 7/29A BETWEEN FND. 2X2 REDWOOD HUBS AND SHOWN HEREON AS N 89°38'00" W
