CORNER RECORD

Document Number 3527-34-92

Brief Legal Description CENTERLINE MONUMENT, MAMMOTH VISTA NO. 2, 534, T.35, R.27E, M.D.B. & M.

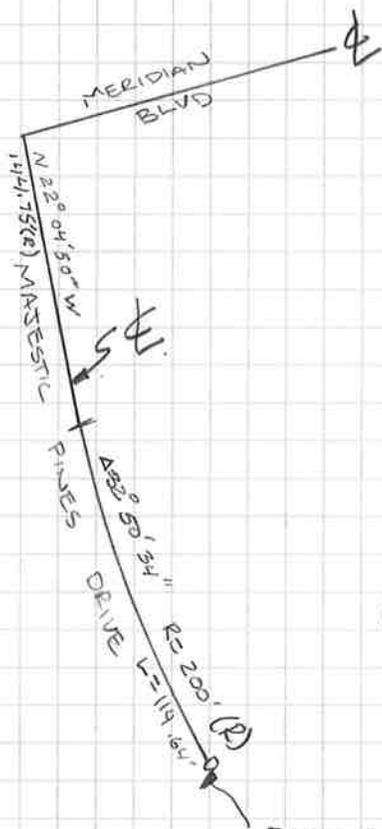
(R) Record data per MB 8/9

DIRECT REPLACEMENT OF
 FINE RR SPIKE PER MB 8/9
 DESTROYED DURING ROAD CONSTRUCTION
 WITH 2" PK $\frac{1}{2}$ " WASHER "LS 4587"
