CORNER RECORD

Document Number 3527-34-95

Brief Legal Description CENTERLINE MONUMENT, MAMMOTH VISTA NO. 2, S34, T3S, R. 27E MDBEM

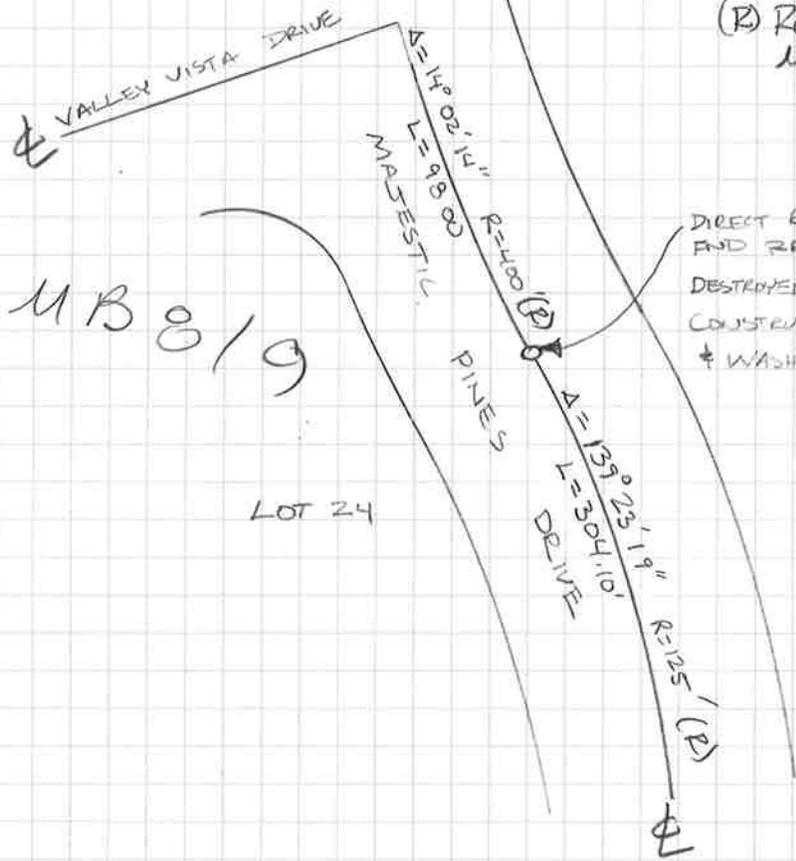
NO SCALE
(B) Record data per
MB 8/9

MB 8/9

LOT 24

DIRECT REPLACEMENT OF
AND RR SPIKE PER MB 8/9
DESTROYED DURING ROAD
CONSTRUCTION WITH 2" DK
WASHER "LS 4587"

A description of the physical condition of the monument as found and as set or reset: SET 2" PK & WASHER "LS4587"

AS A DIRECT REPLACEMENT OF RR SPIKE @ THE POINT OF REVERSE CURVE SOUTH OF LOT 24 AND WEST OF THE INTERSECTION OF VALLEY VISTA DRIVE & MAJESTIC PINES DR. DESTROYED DURING ROAD CONSTRUCTION
