CORNER RECORD

Document Number 3527-34-97

Brief Legal Description CENTERLINE MONUMENT, MAMMOTH VISTA NO. 3, S34, T3S, R.27E MDBEM

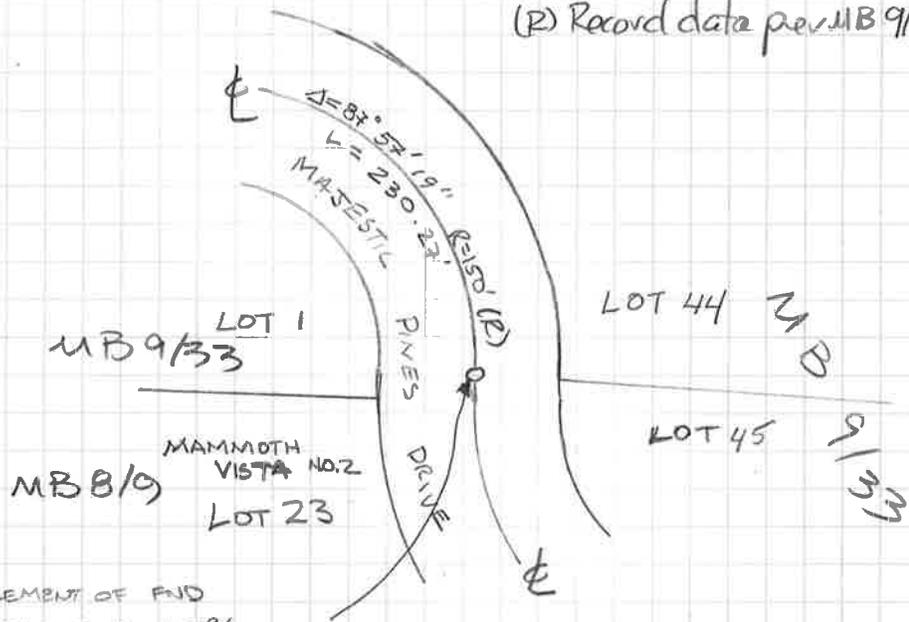
(P) Record data per MB 9/33

DIRECT REPLACEMENT OF FND  
2" IP RCE 15160 PER MB 9/33  
DESTROYED DURING ROAD CONSTRUCTION,  
WITH 2" PK WASHER "LS45B7"

"LS 4587" AS A DIRECT REPLACEMENT OF 2" IRON PIPE END PER MB 9/33 @ THE POINT OF REVERSE CURVE NORTHEAST OF LOT 45. DESTROYED DURING ROAD CONSTRUCTION
